# TRIPLE DECKERS

A Publication of The New Haven Preservation Trust

Published by The New Haven Preservation Trust, 1985

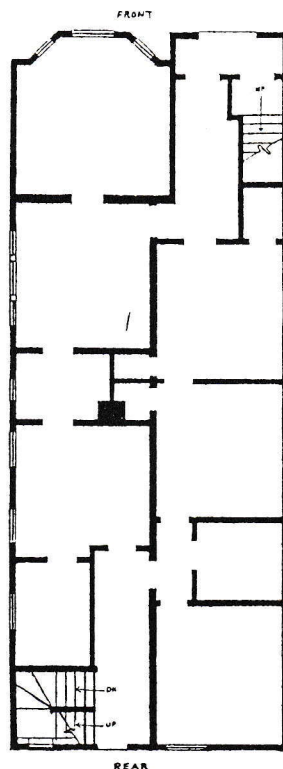
FLOOR PLAN

In its purest form, a Triple Decker is a narrow, freestanding, 3-story, rectangular wooden box containing a stack of three, virtually identical apartments accessed by common front and rear stairwells. Triple deckers display a broad range of variations on this basic theme. Some have gable roofs, others have gambrel roofs; some have projecting window bays, others do not; some have 3-story porches, others have 1- or 2-story porches; some are built of brick, others of concrete block; some are paired versions, essentially two Triple Deckers built side by side and sharing a common bearing wall. These are commonly known as "Perfect Sixes."

TYPICAL TRIPLE DECKER

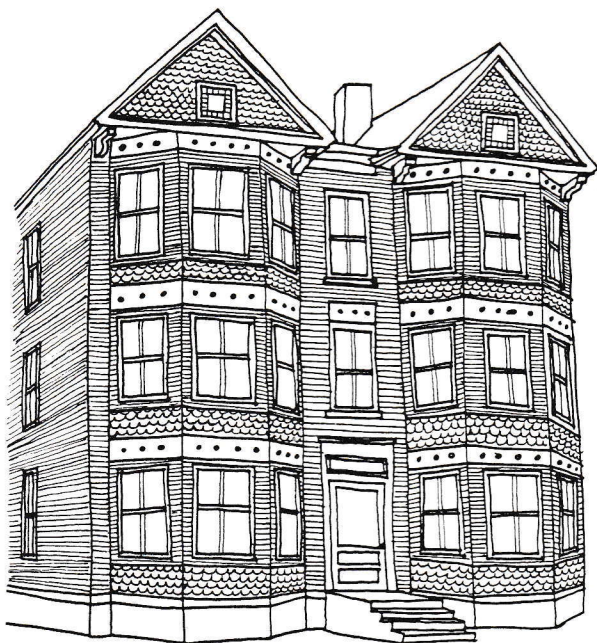
The Queen Anne style was very popular across the country from the early 1880s through the first few years of the twentieth century. Typical Queen Anne-style features found on Triple Deckers include different types of siding materials which create interesting patterns and textures (usually horizontal clapboards and decorative wood shingles); prominent scroll-sawn brackets under the roof eaves; elaborately detailed porches with turned posts and balusters; and large arched openings with turned or carved decorative elements.

QUEEN ANNE ~ STYLE "PERFECT SIX"

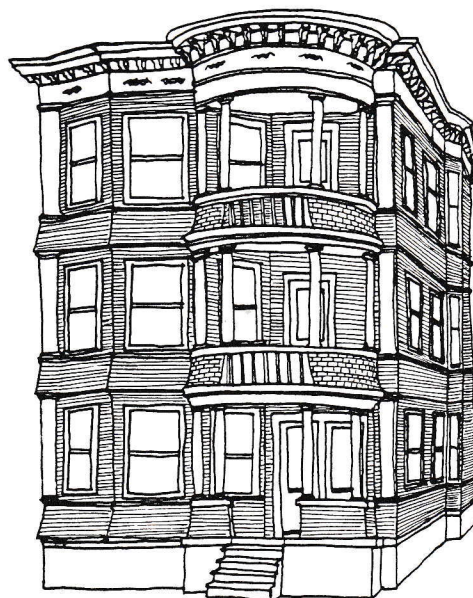
The Colonial Revival-style ornamentation which began to appear on Triple Decker fronts in the late 1890s was less exuberant and fanciful than that of the Queen Anne style. Different siding materials gave way to uniform clapboarding on all exterior wall surfaces; elaborate turned porch and railing posts were replaced by plain columns, piers, and solid or picket railings; and scroll-sawn eave brackets were eliminated entirely or supplanted by more refined and "formal" box-like modillion brackets.

COLONIAL REVIVAL ~ STYLE TRIPLE DECKER

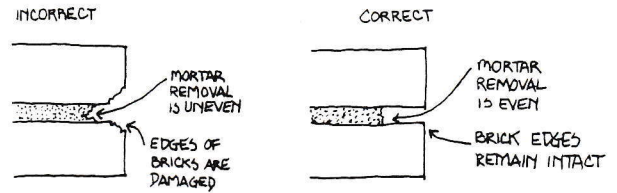
#### REPOINTING: REMOVING OLD MORTAR

Deteriorated mortar should be repointed. Loose mortar should be removed from the affected area by hand with a hammer and chisel to a uniform depth of 1/2-1". To ensure a good bond, flush chiseled joints with water

prior to refilling them with new mortar. **Important Precautions:** When removing old mortar, do not chip the edges of the surrounding bricks. This will accelerate the deterioration of the brick. Make sure that new mortar matches the color and composition of the original mortar. Most older buildings have bricks designed for use with soft lime mortar; hard cement-based mortars can eventually damage the surrounding bricks. If you are unsure of the type of mortar to use, have some of the original analyzed at a high school or college chemistry laboratory to determine the proper mix. Finally, never refill a joint completely; finished joints should always be slightly recessed.

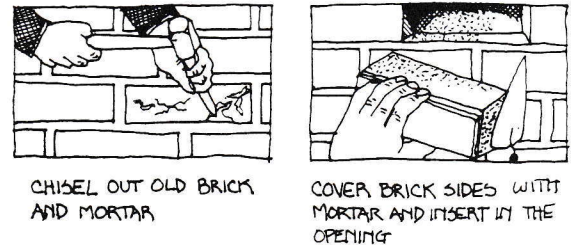
#### REPLACING A DAMAGED BRICK

Minor cracks in bricks can usually be repaired by filling them with tinted sealant designed for that purpose. Severely cracked, broken, or spalling bricks should be replaced by chiseling out the damaged brick and surrounding mortar, laying a shallow mortar bed on the bottom, top, and sides of the cavity, and inserting a brick "battered" on all but the finish side with mortar prior to final pointing. The new brick should match the original brick as closely as possible in size, color, and texture.

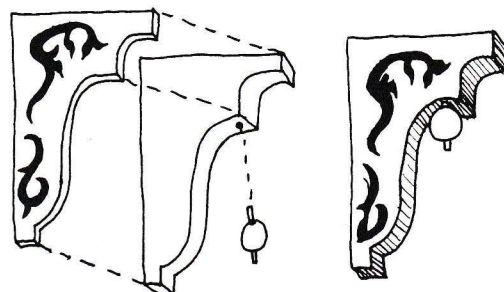
### DUPLICATING A BRACKET

PLYWOOD CUT-OUT WITH FLORAL DESIGN IS APPLIED TO BRACKET BLOCK WITH GLUE

FINISHED BRACKET WITH SANDED JOINTS AND BALL PENDANT

replacement of partially rotted or broken features such as porch posts and railings. With the use of such materials, rotted sections can often be cut out and refilled; and broken or cracked brackets, balusters, moldings, doors, and other wooden features can often be reglued. Features beyond repair can be reproduced with a jig or sabre saw and drill and stock lumber, using an intact, similar feature as a model. Intricate features such as brackets can often be made in sections and then glued together with waterproof epoxies. If exact reproduction of a feature such as a molding is not possible, approximate the size and shape of the original as closely as you can. If a major feature such as a front porch is missing entirely, try to locate an old photograph on which to base the design of the new porch. If you cannot find a photograph, look at similar nearby buildings which retain old porches; these may help to give you an idea of the size, shape, and details of the porch which was removed from your own building.
